Report on
Geotechnical Desktop Review

Tuggerah Gateway Development
60 Wyong Road, Tuggerah

Prepared for
Scentre Limited

Project 202794.00
September 2021

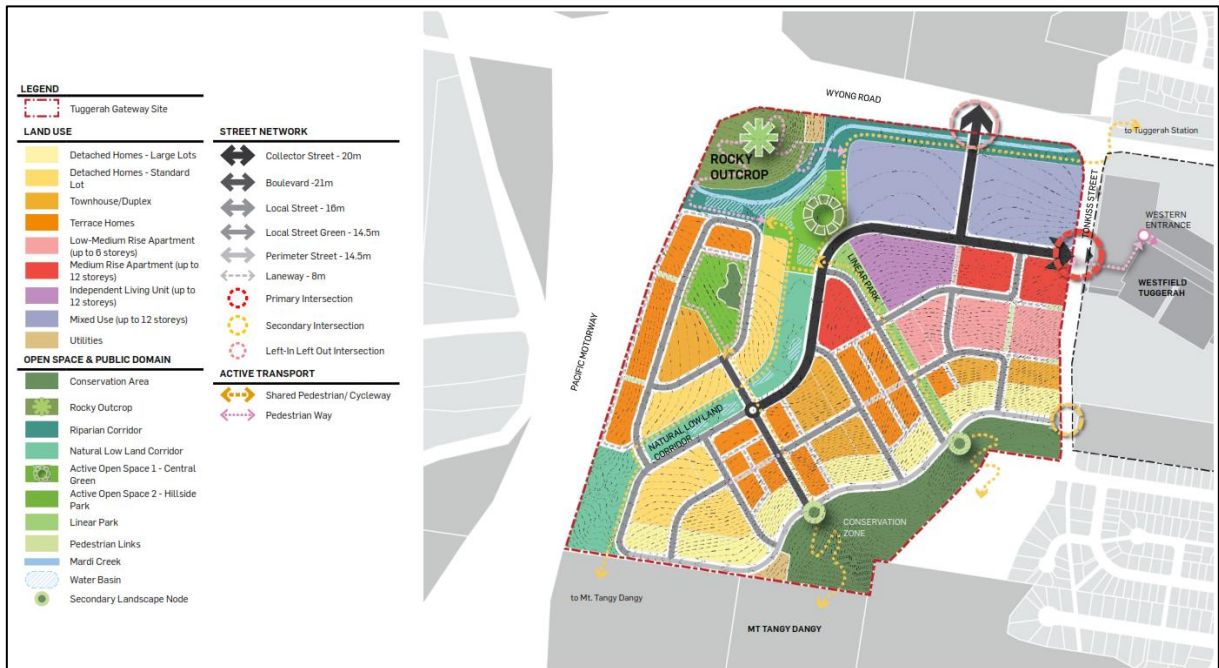
Figure 1: Concept Plan

Consistent with the Structure Plan, as shown Figure 1 on the following page, the future development of the site is to be staged in accordance with market demand and infrastructure requirements. In the short-term employment uses in the form of bulky goods / large format retailing will be prioritised in part of the B4 Mixed Use zone. In the longer term this area is envisaged as a mixed-use precinct.

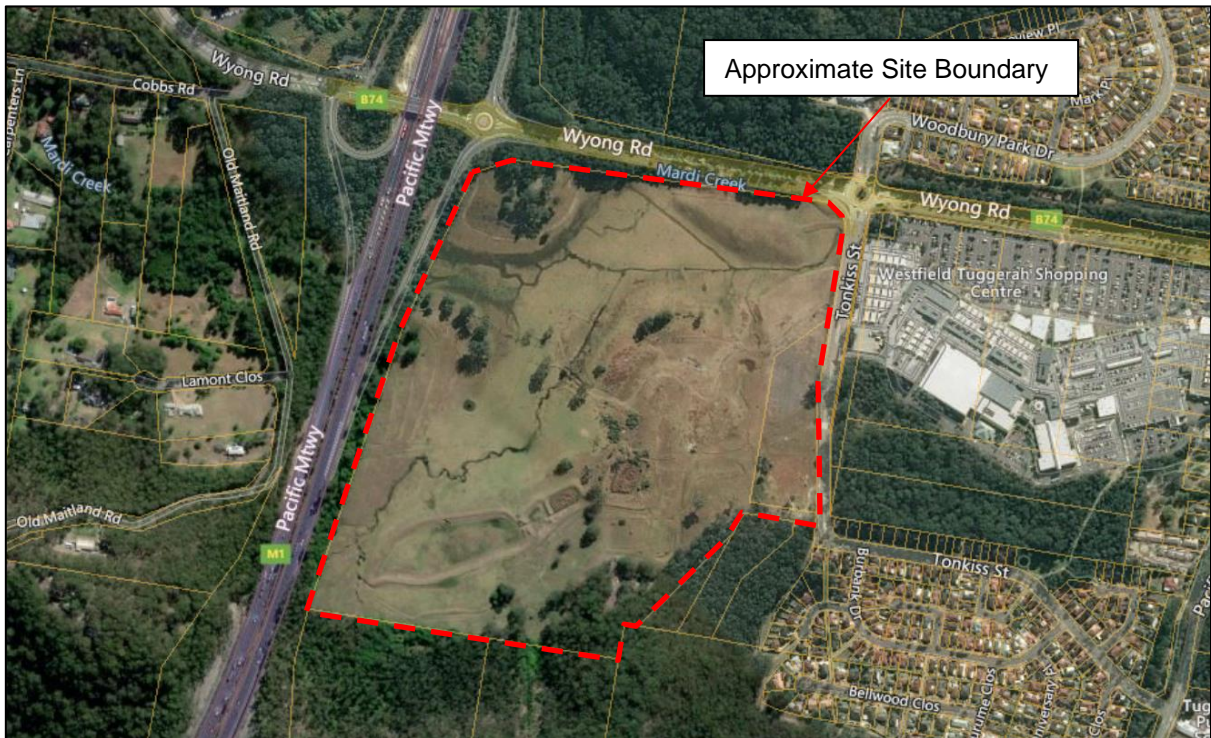
Figure 2: Aerial view of the site

An aerial view of the site is shown in Figure 2 below.

At the time of the investigation, the site was unoccupied and generally grass covered.

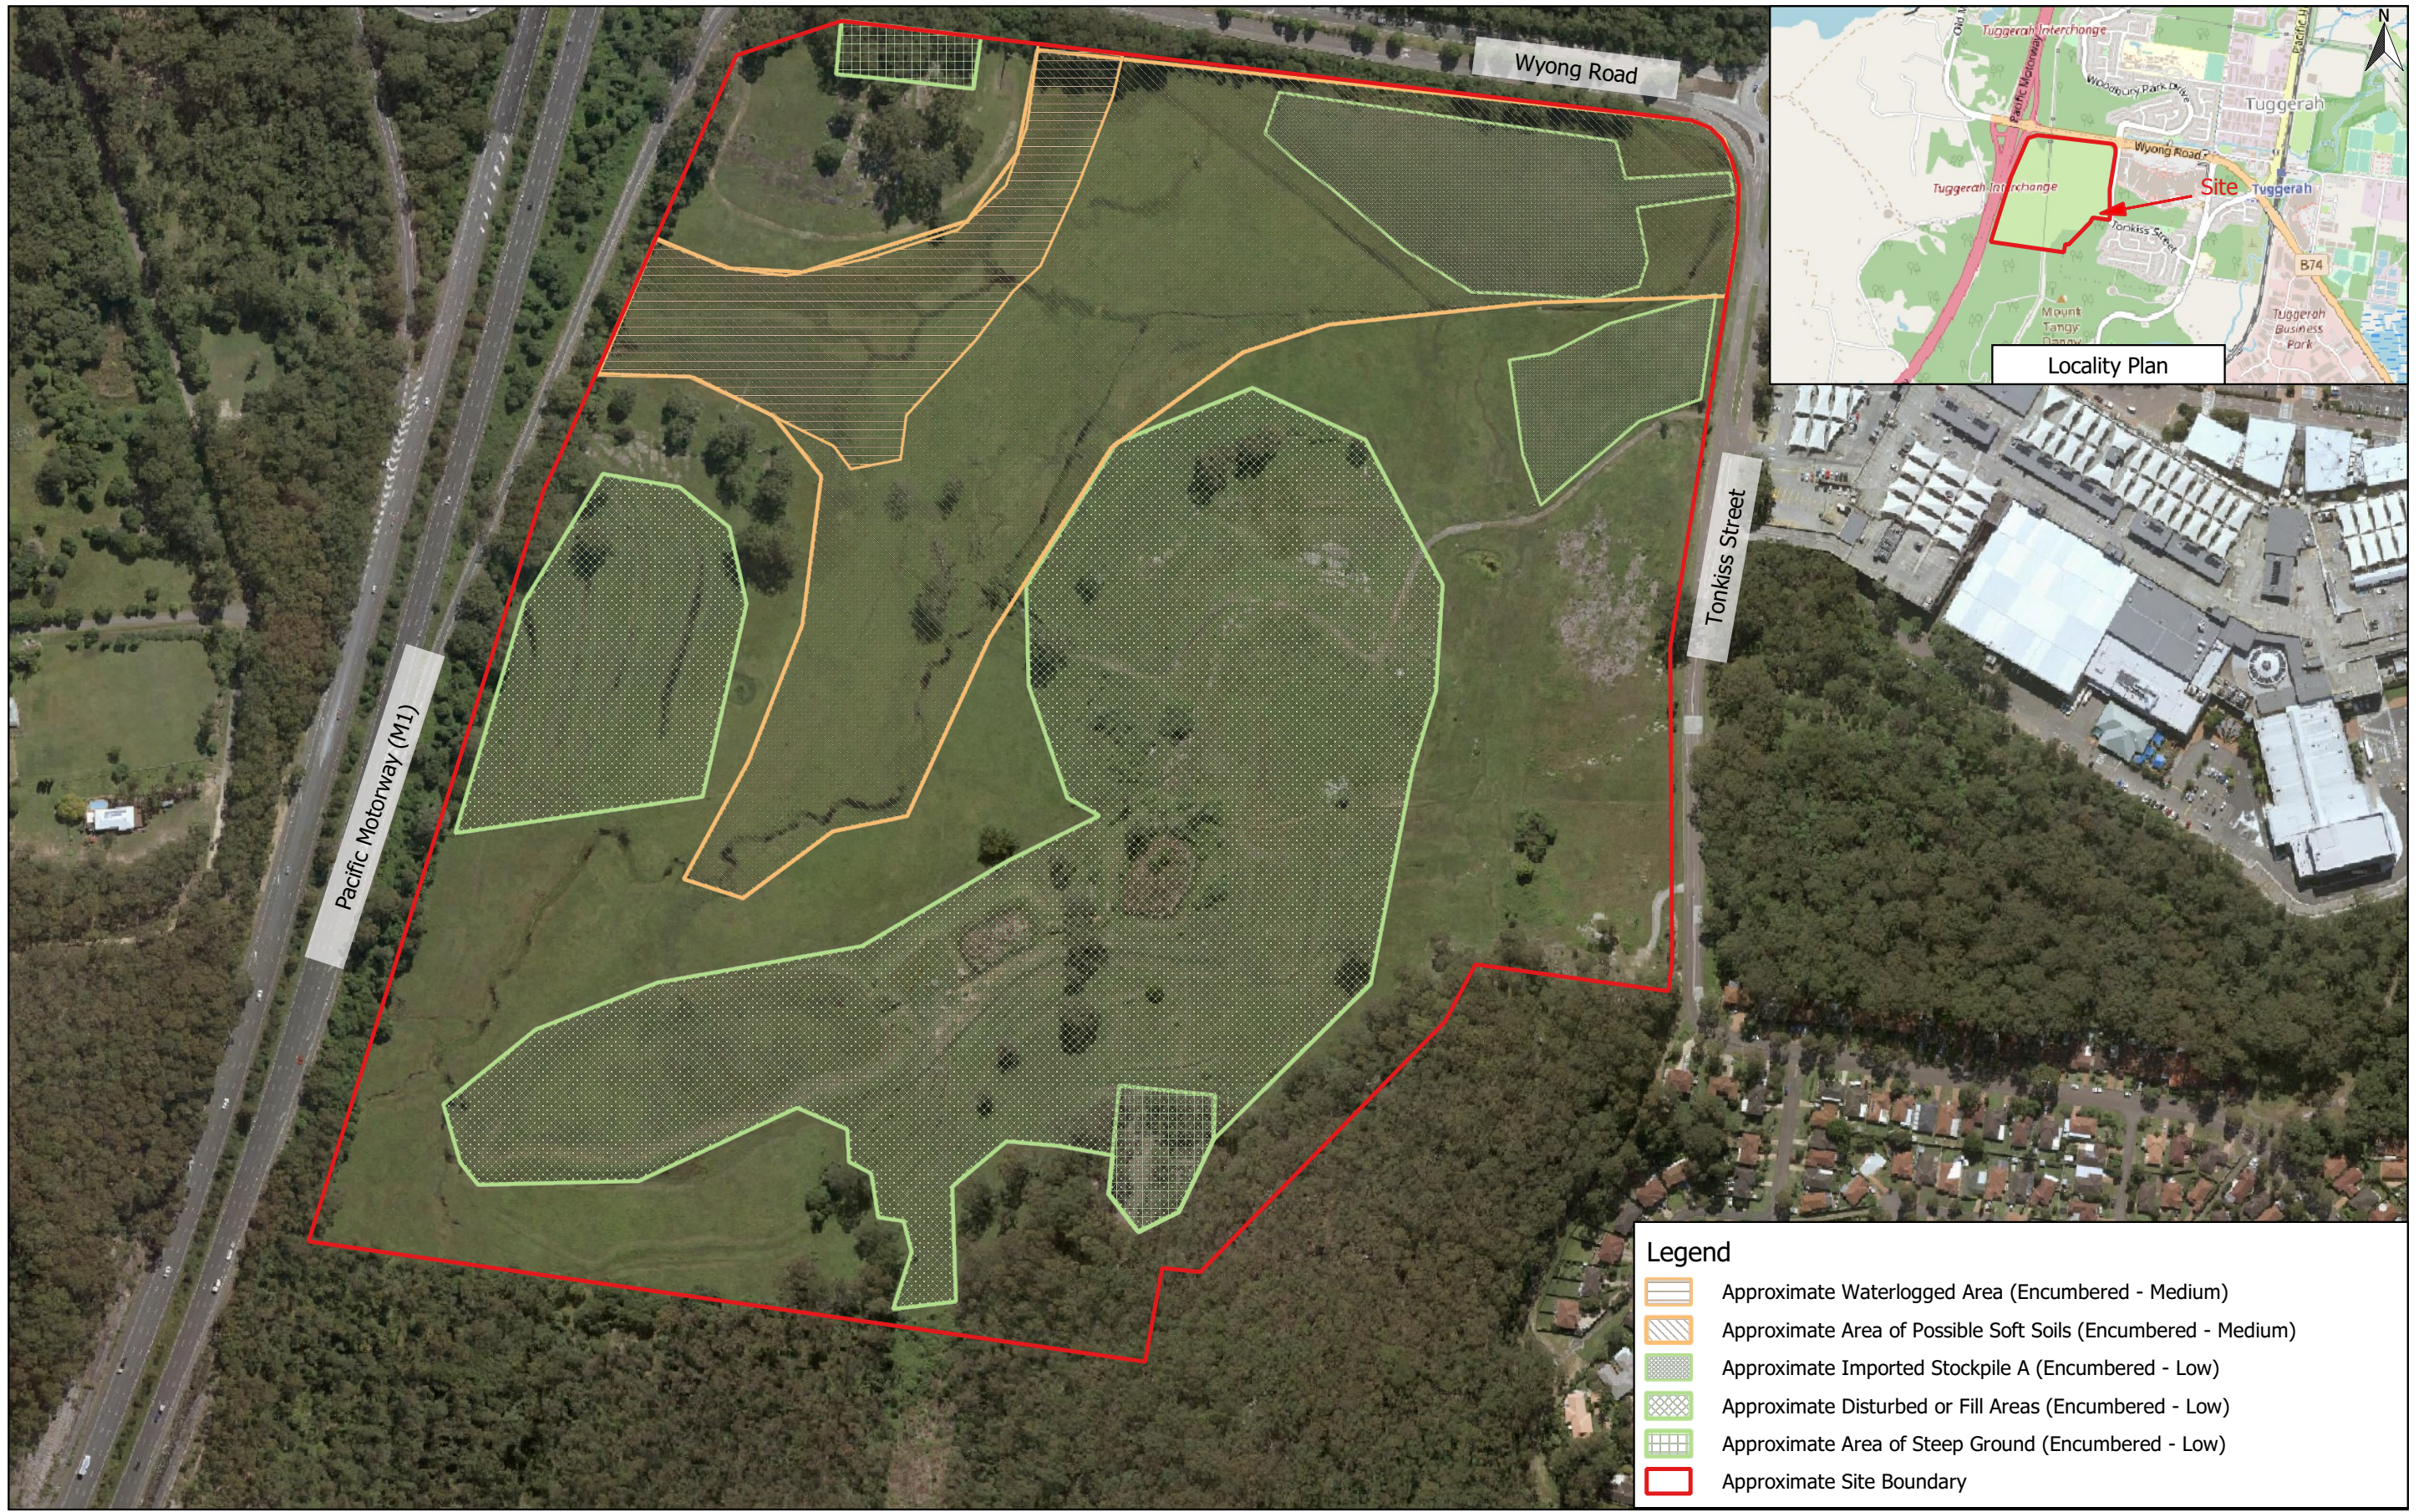
The anticipated constraints to the proposed development, from a geotechnical perspective, are summarised below. Drawing 1, in Appendix C also shows the approximate extent of the affected areas.

Based on the results of the walkover inspection, waterlogged soils are likely to be present during construction, particularly in the northern, low lying, area of the site and where drainage gullies are present. The extent shown on Drawing 1 (Appendix C) is indicative of the waterlogged soils observed at the time of the site walkover. Depending on the conditions leading up to and at the time of construction, other areas may be affected by waterlogged soils.

Based on the results of previous investigations at and adjacent to the site, weak alluvial soils may be present in the northern, low lying area of the site. Based on previous investigations, the weak soils may extend to depths up to approximately 5 m below the natural ground surface and hence may be considered unsuitable for support of high level footings.

The area of expected weak soils, as show in Drawing 1 in Appendix C, encroaches upon areas of proposed detached homes, townhouses and terrace homes in the western areas of the site as well as the medium rise apartment, independent living and mixed use development in the central northern area of the site.

A large stockpile of fill material is present within the northern area of the site (refer Drawing 1, Appendix C). Based on the results of previous investigations, the fill material comprises a mix of sand, silt, clay and gravel, as well as some building waste (i.e. concrete etc.). Assessment of the stockpiled fill material has also identified that the fill material comprises a mix of acid sulfate and acidic soil.

Fill material is also expected to be present in other areas of the site (refer Drawing 1, Appendix C), some of which appears to be associated with former abattoir works at the site. It is expected that the fill material may include building waste, based on site observations and previous investigations undertaken.

The areas identified on Drawing 1, Appendix C, include areas of rock cuttings that will be subject to stabilisation. Further detailed assessment will be required to provide advice on appropriate stabilisation measures.

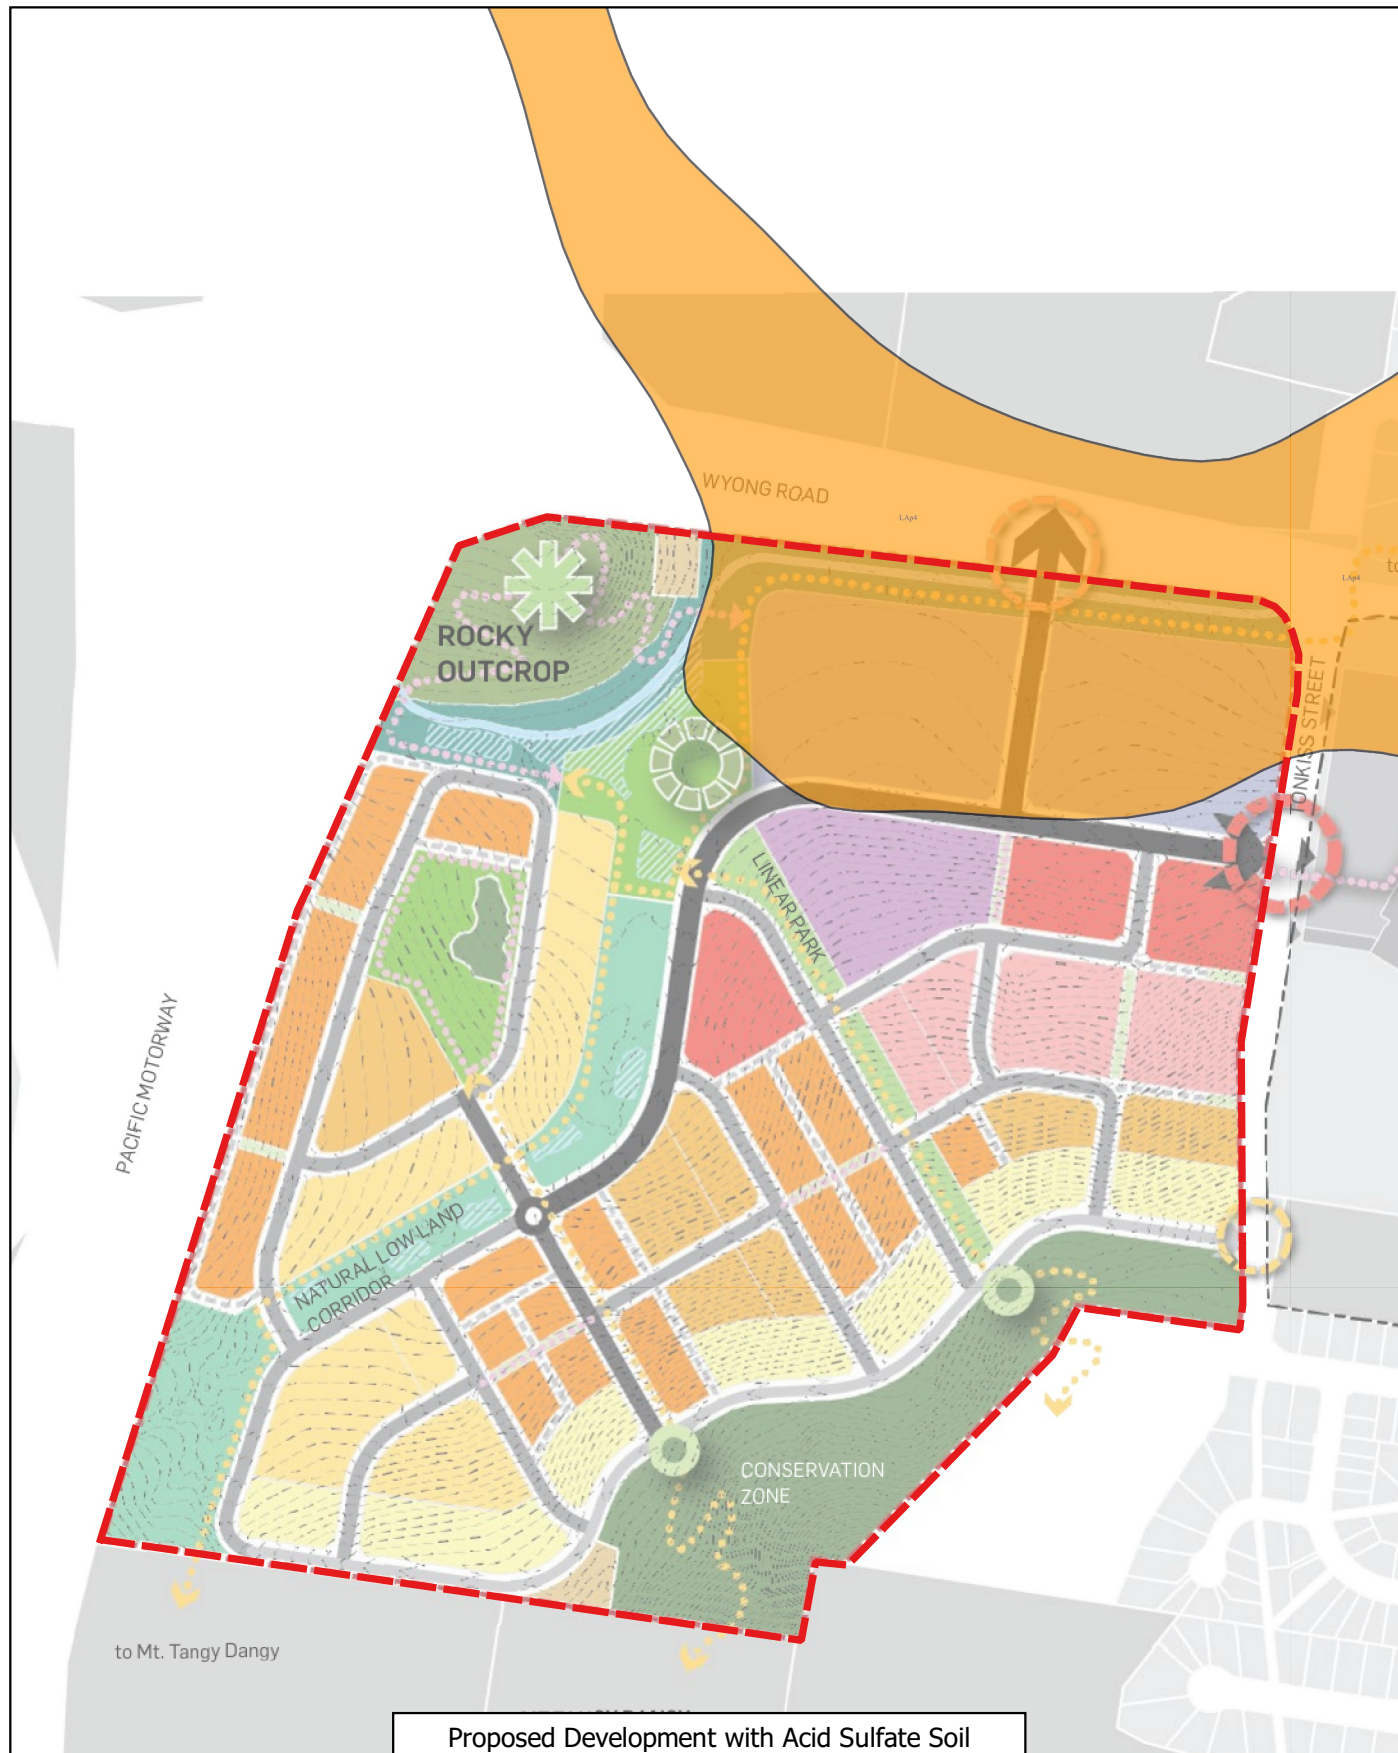
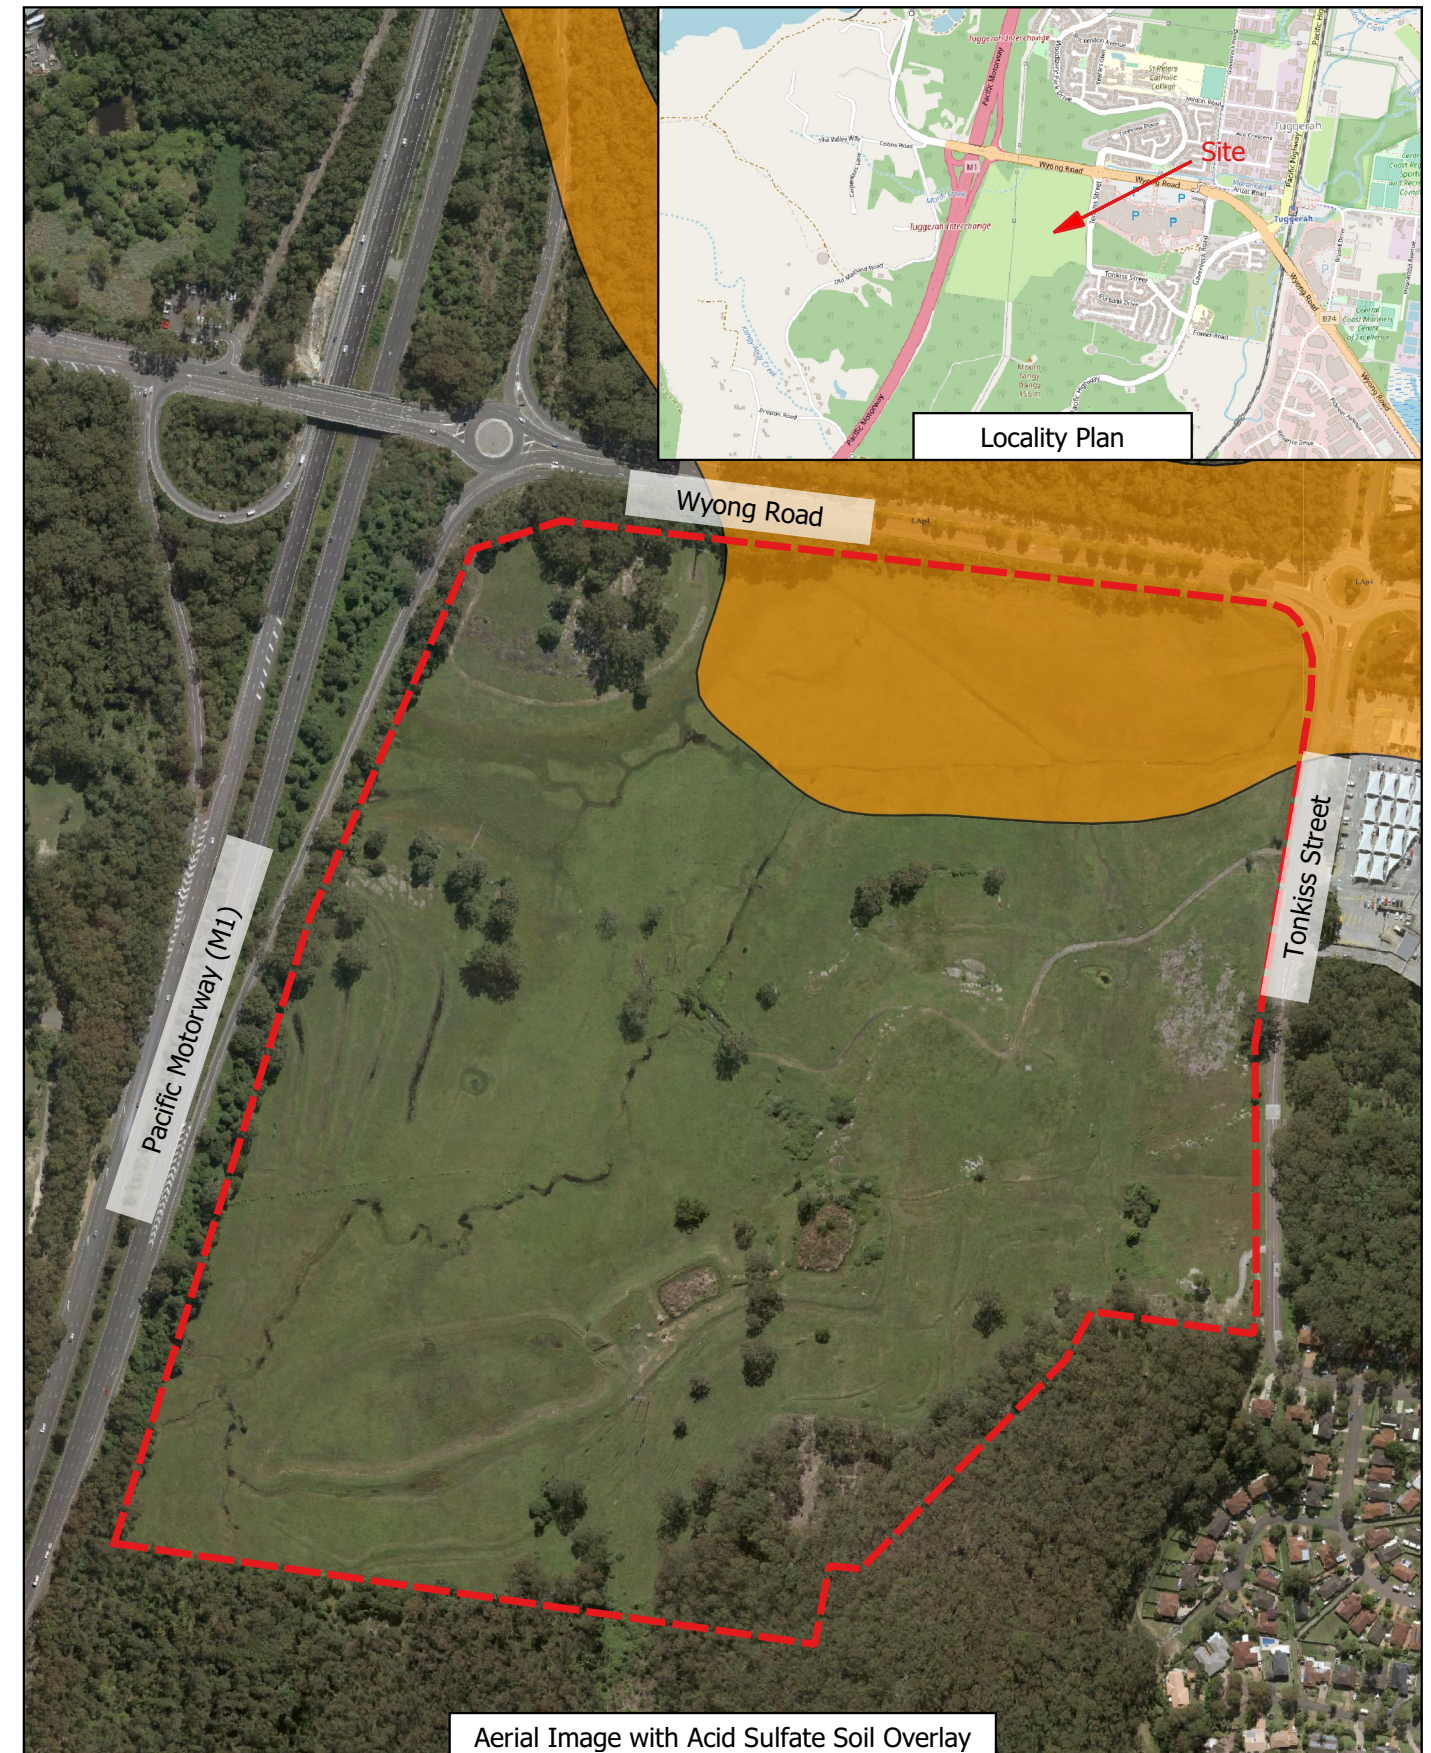
Review of the local acid sulfate soil mapping indicates that the lower, northern area of the site is mapped as having a low probability of acid sulfate soils at depths greater than 3 m of the natural ground surface.

Drawing 4 in Appendix C shows the mapped acid sulfate soil risk for the site.
