Wamberal Terminal Coastal Protection Assessment

## DRAFT FINAL Stage 1 – Review of Previous Studies

May 2021

Prepared for:  
Central Coast Council

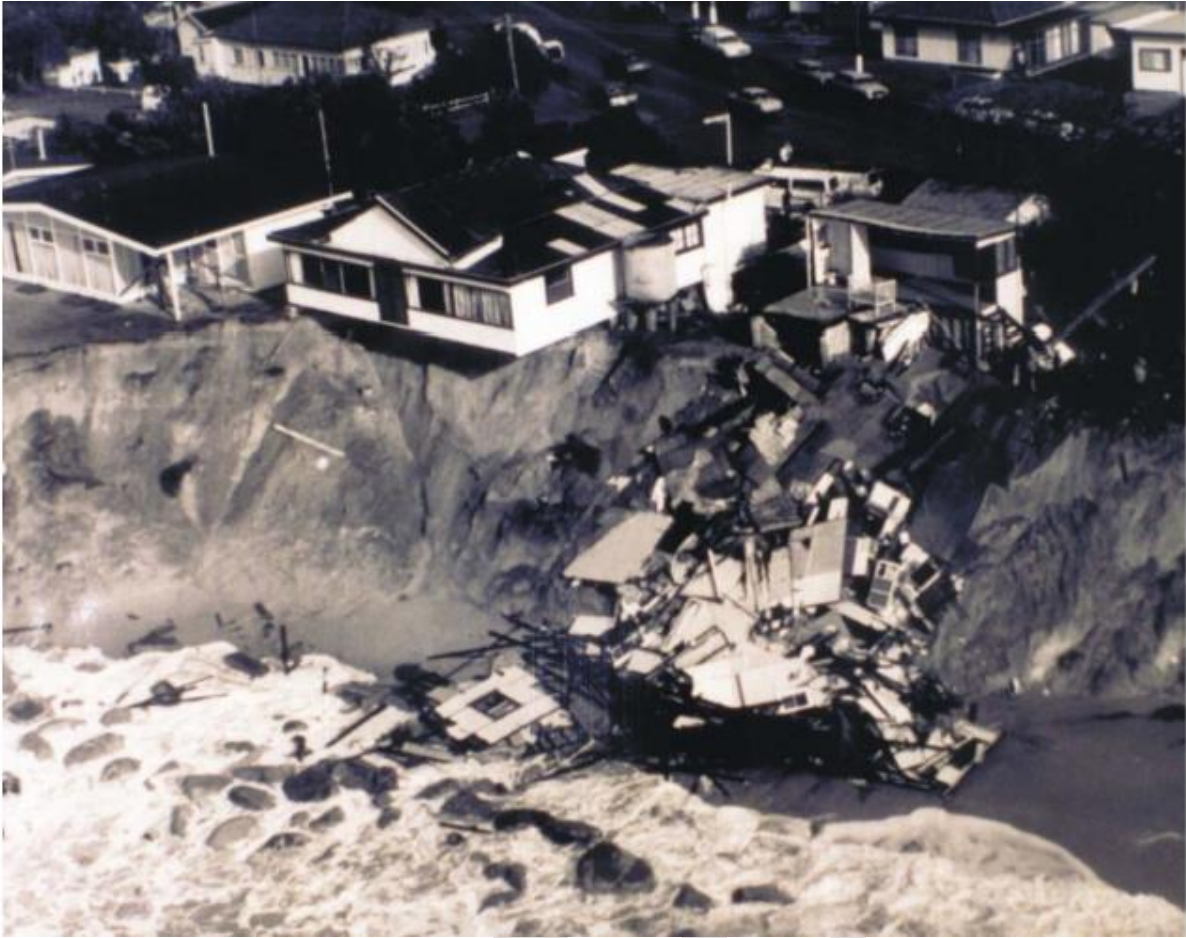
**Figure 3.2 Collapse of house at 23b Ocean View Drive Wamberal in June 1978 (News Limited)**

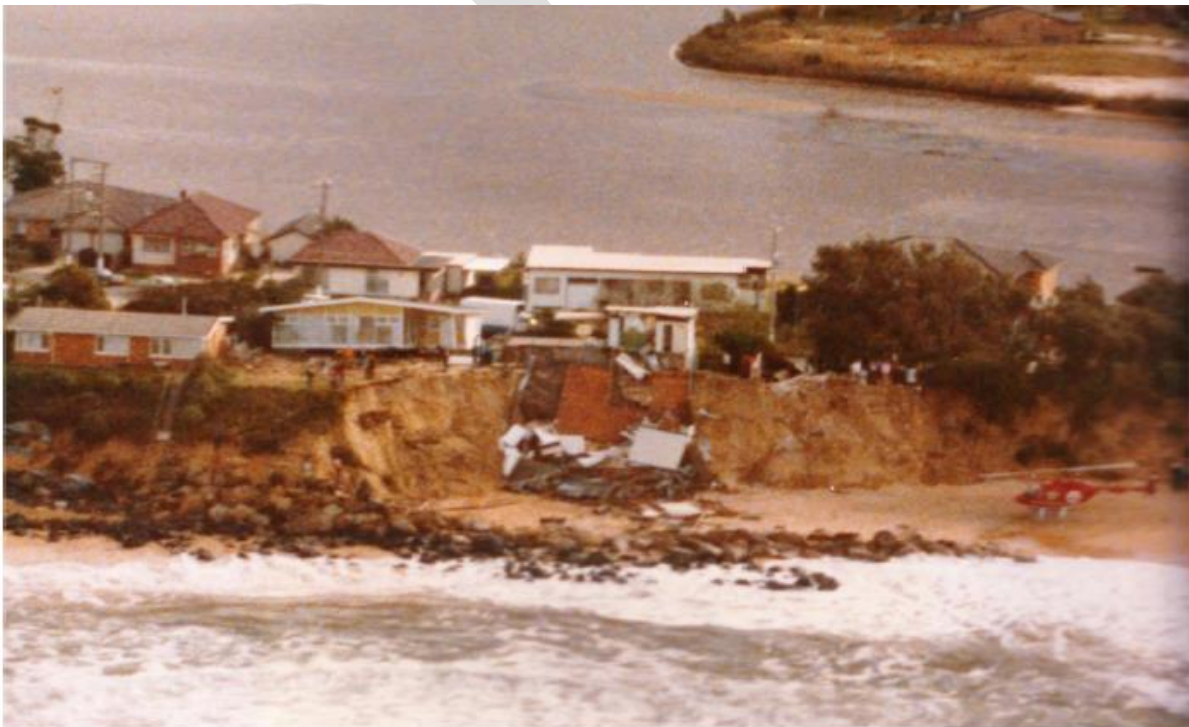
Note: 33 Pacific Street (to its immediate left) having been relocated 10m landward

**Figure 3.3 Collapse of house at 23a Ocean View Drive Wamberal in June 1978**

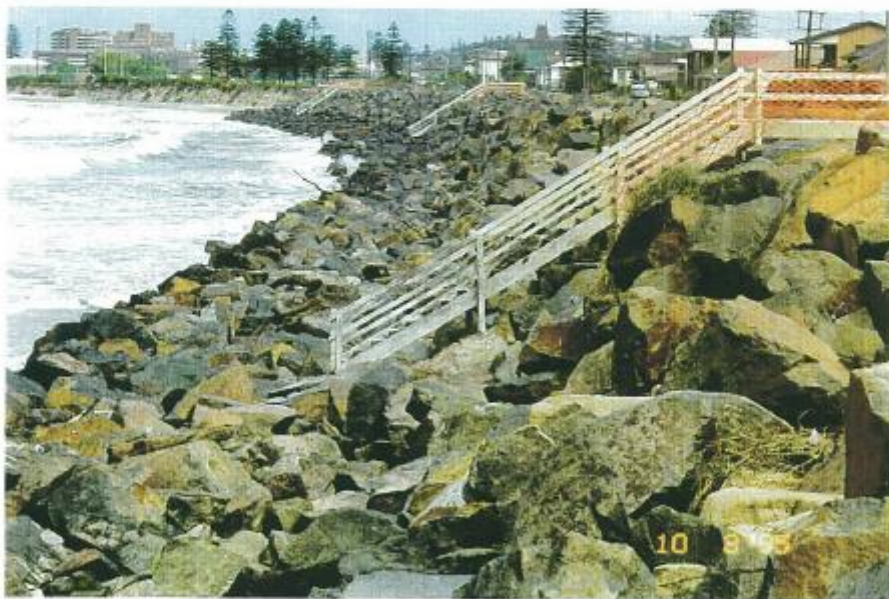
**a) Typical Pre-Storm Conditions**

**b) Typical Post-Storm Conditions**

*\* It is noted that this structure has been designed for significant wave overtopping.*

**Figure 4.2 Basalt option**

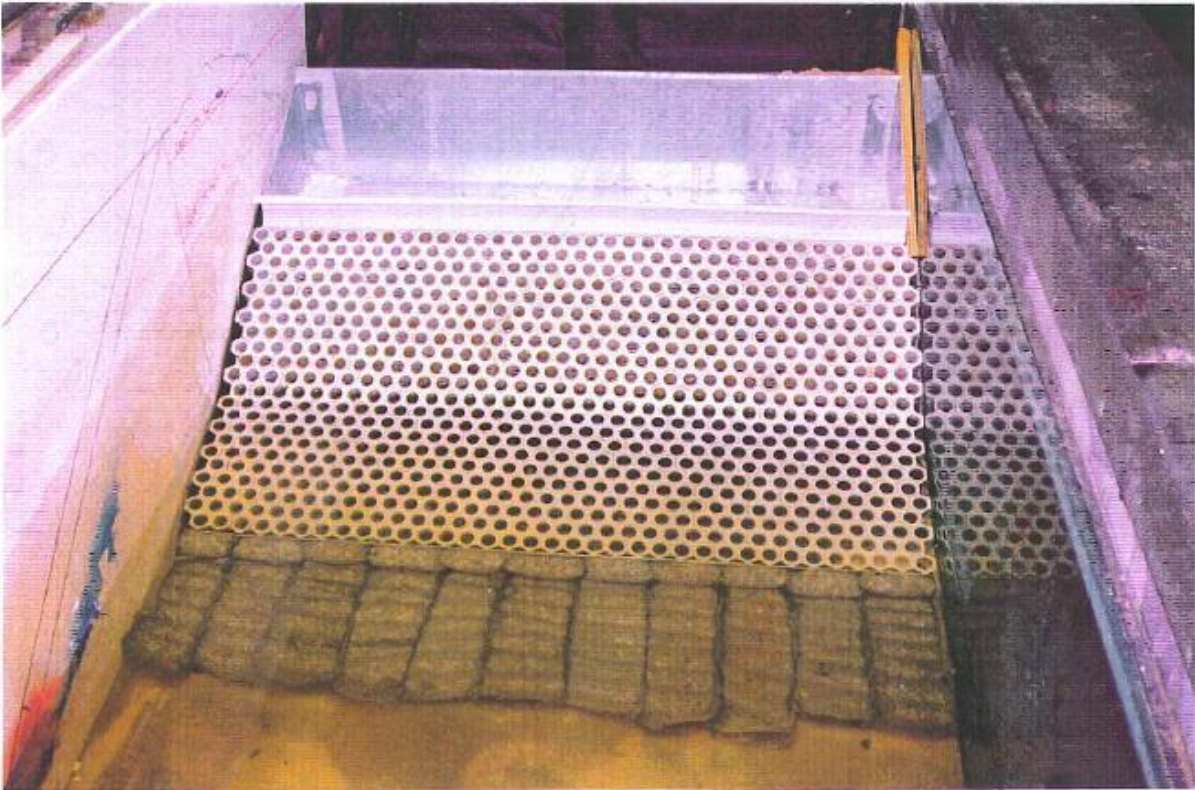
Figure 4.12 Overhead view of Seabees in flume

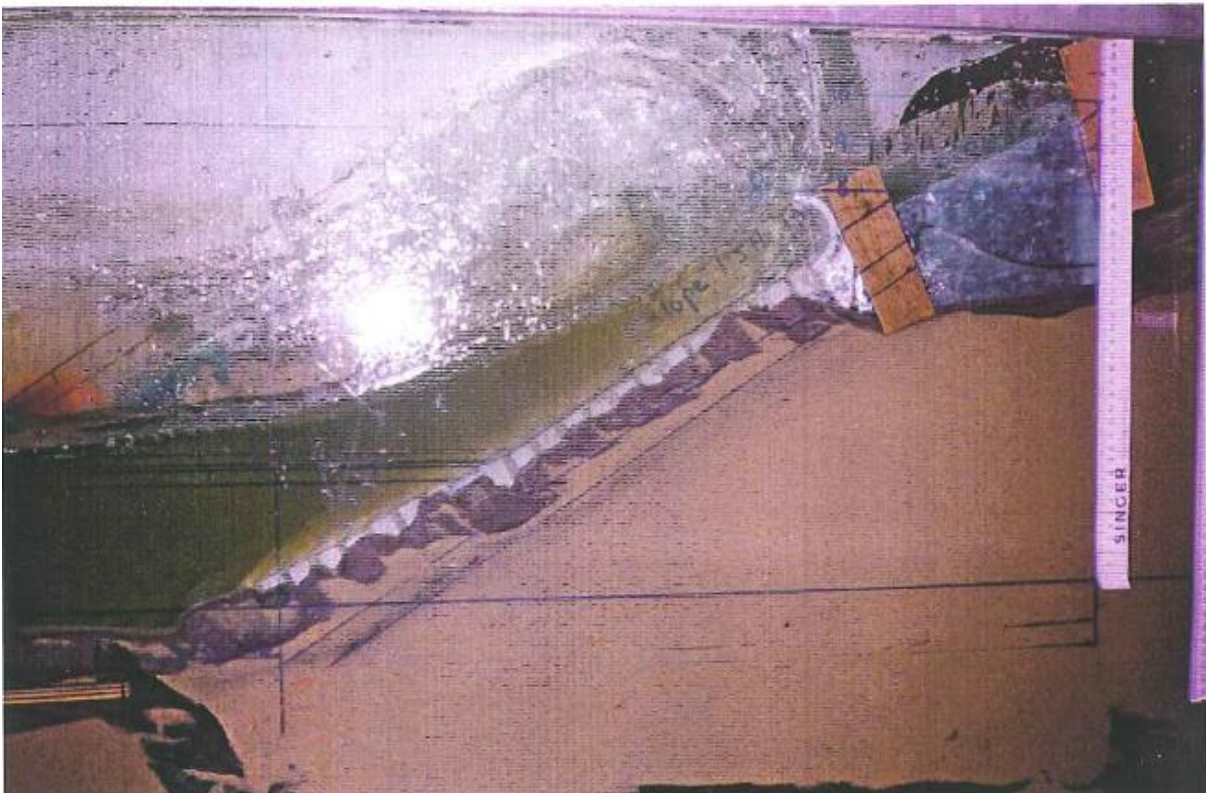
Figure 4.13 Side view of wave runup

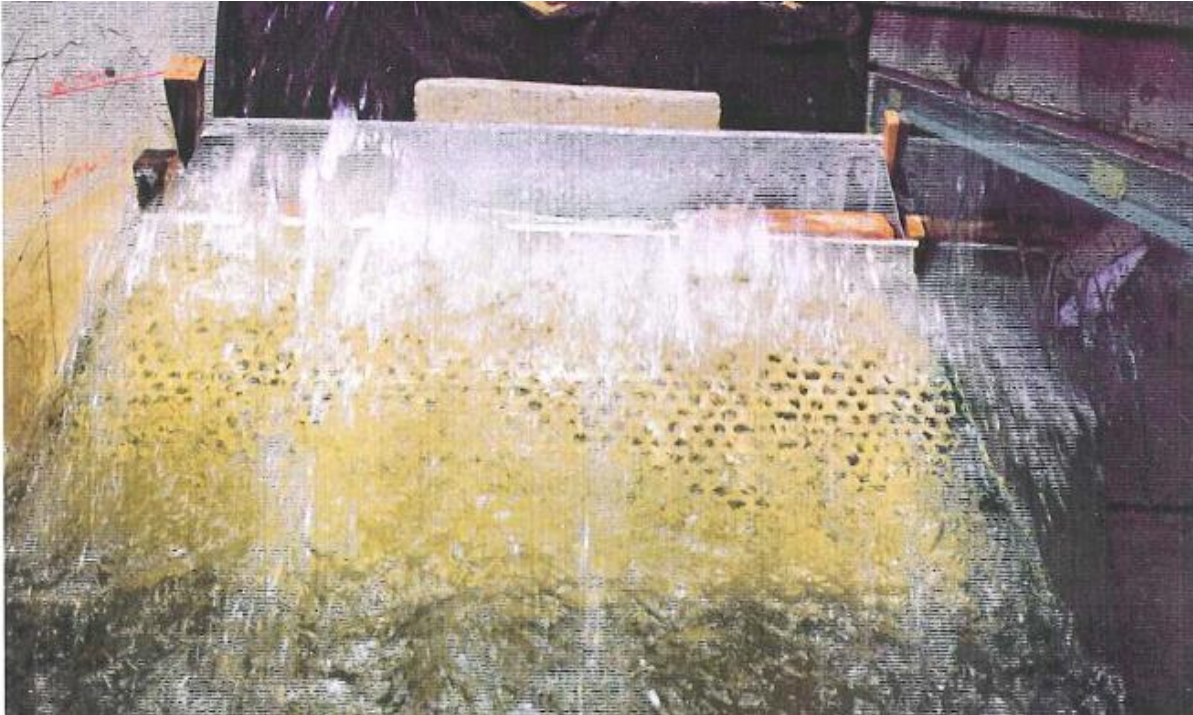
Figure 4.14 Overhead view of wave runoff

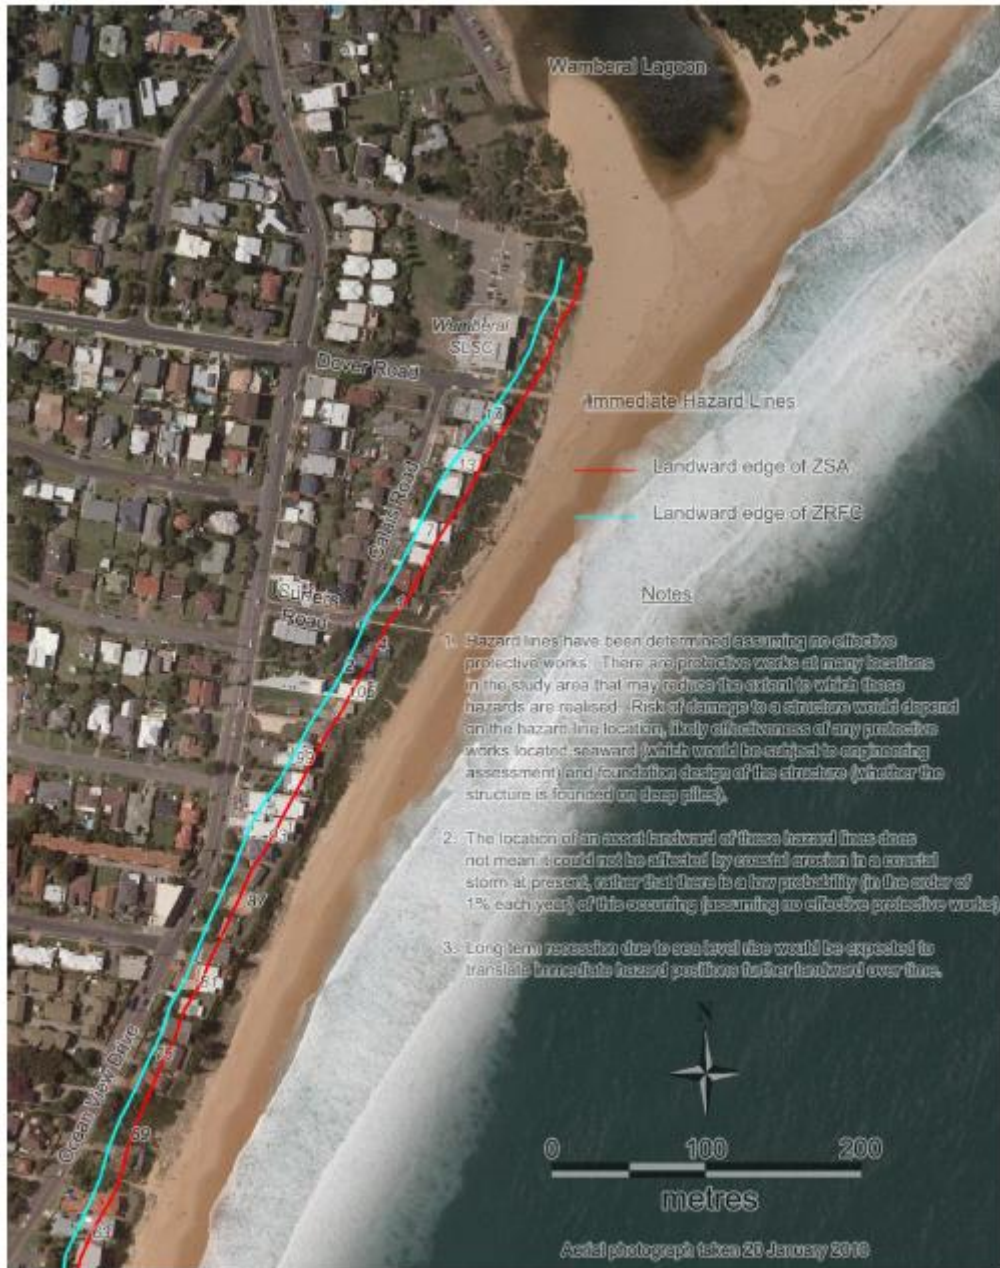
Figure 22: Immediate Coastline Hazard Lines at landward edge of Zone of Slope Adjustment (ZSA) and Zone of Reduced Foundation Capacity (ZRFC) in northern half of study area (ignoring protective works)

Figure 7.3 Present day coastal hazard lines - north (WP, 2015 Figure 21)

The cross section used for defining coastal hazard lines is shown in Figure 7.1. Surface hazard lines depicting the landward limit of the Zone of Slope Adjustment (ZSA) and Zone of Reduced Foundation Capacity (ZFRFC) are shown in Figure 7.2 and Figure 7.3. It should be noted that the hazard lines ignore existing ad-hoc protection works and rock outcrops, and will be located further

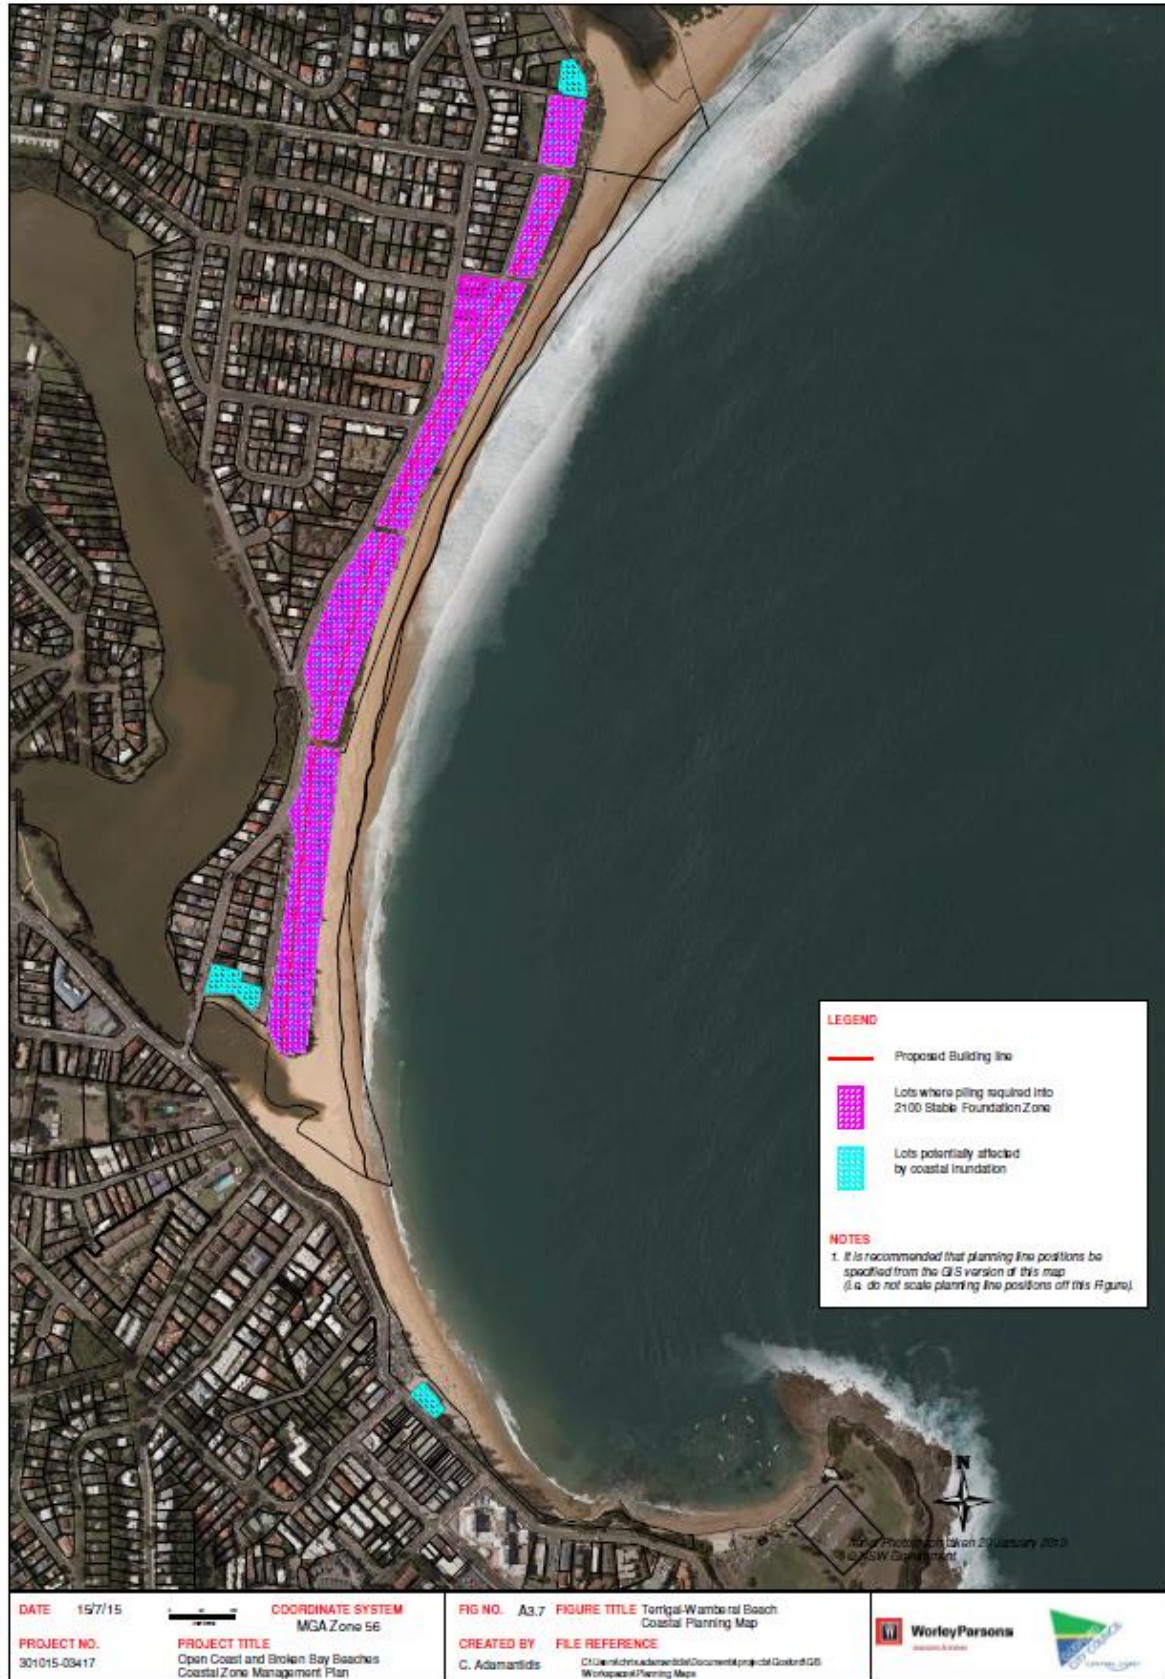
Figure 7.4 Lots potentially affected by coastal hazards (WP, 2015 Figure A3.7)

Lots potentially affected by coastal hazards to 2100 are show in Figure 7.4.

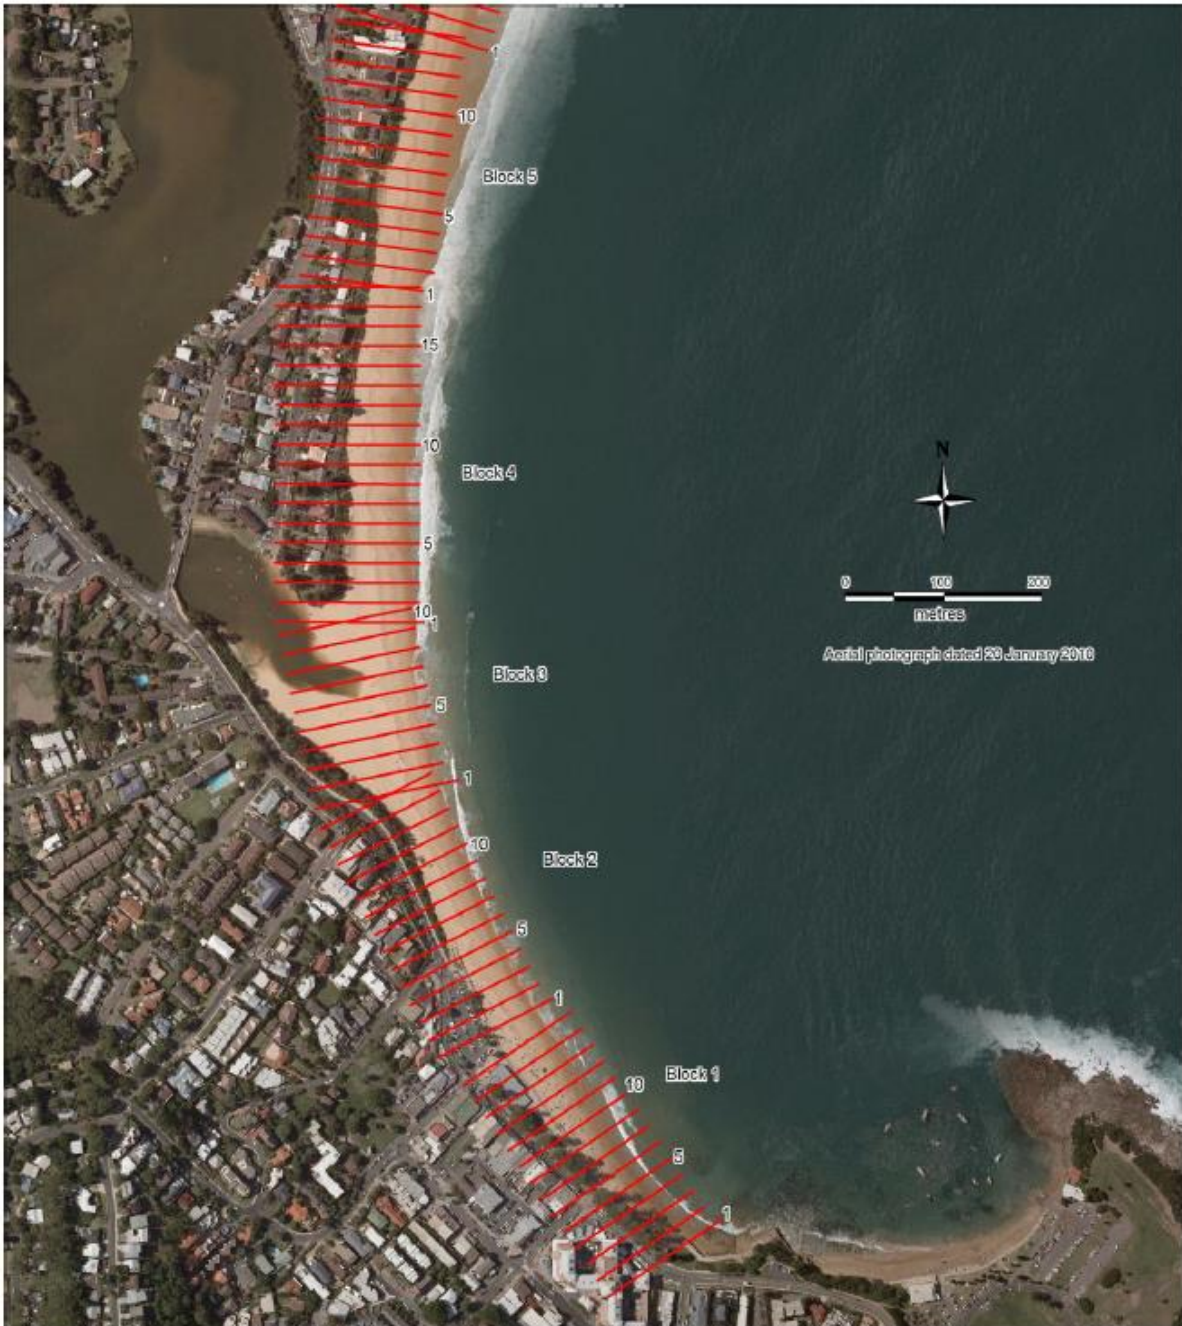
Figure 7.5 Photogrammetry blocks 1 to 5 (WP Figure H1)

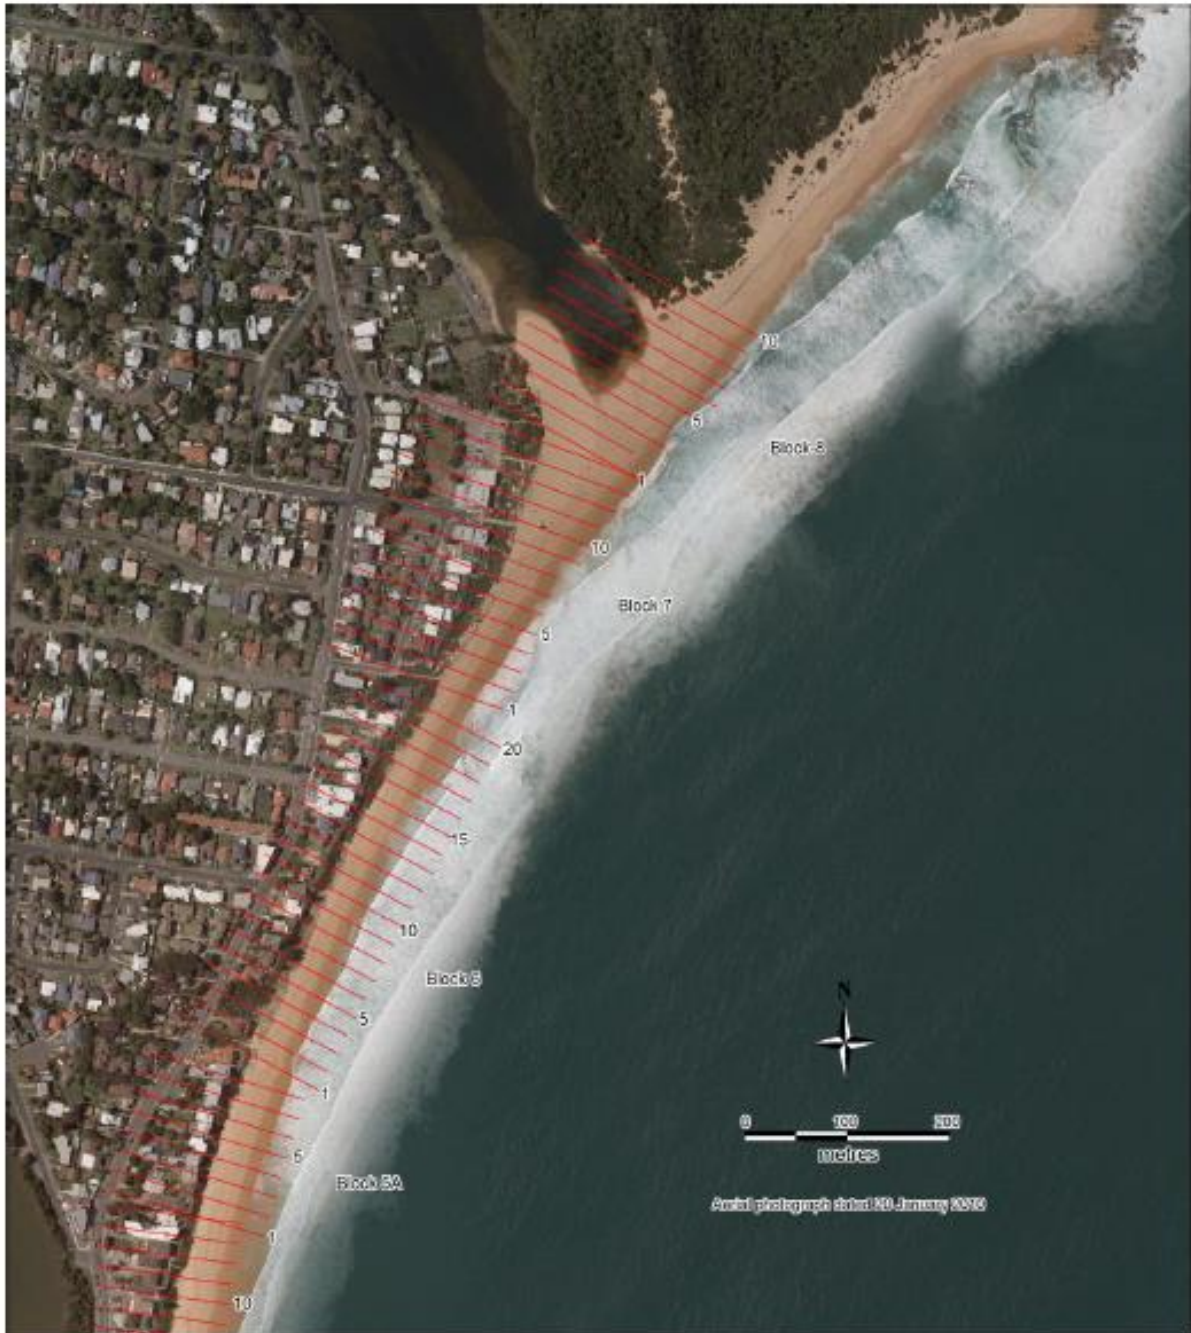
**Figure 7.6 Photogrammetry blocks 5A to 8 (WP Figure H2)**

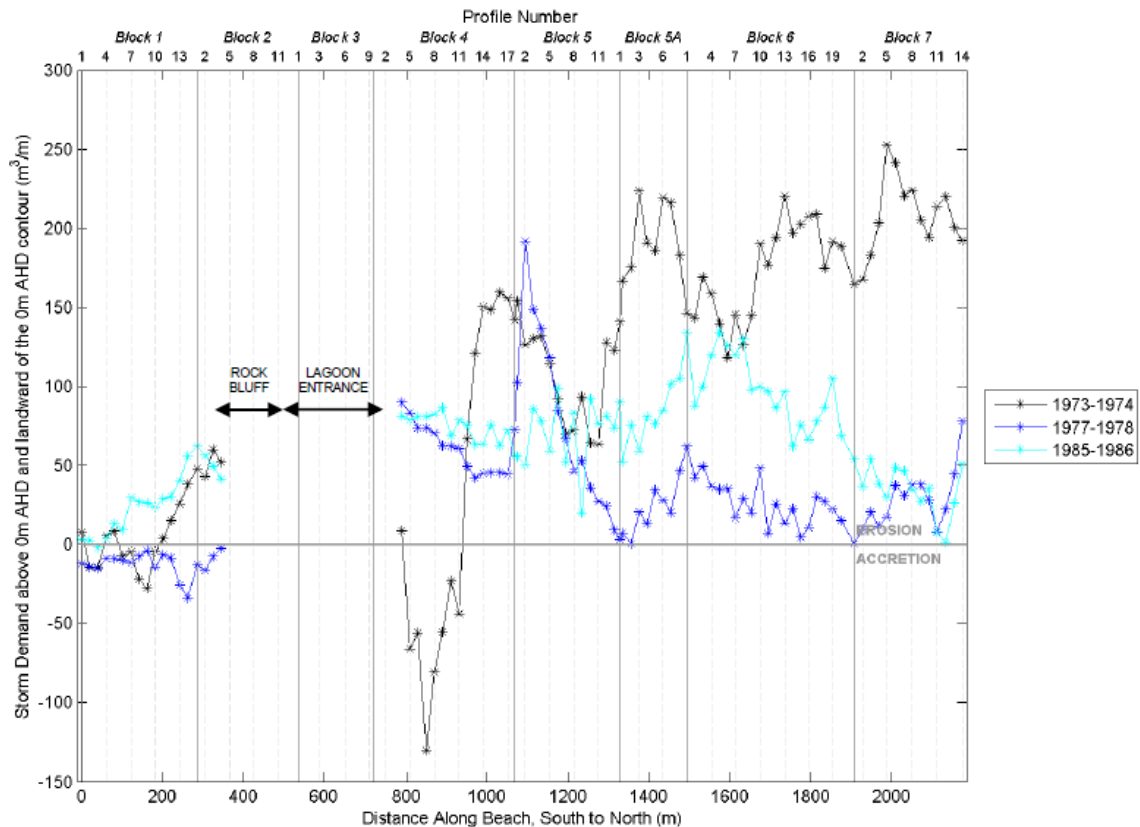
**Figure 7.7 Alongshore volume change (WP Figure H8)**

- There were three major storm events captured in the photogrammetry, with alongshore volume change shown in Figure 7.7:
  - October 1973 to June 1974 (May-June 1974 storm event)
  - January 1977 to August 1978 (June 1978 storm event); and
  - September 1985 to August 1986 (August 1986 storm event).
- Peak storm erosion of 250 m<sup>3</sup>/m above AHD was measured at Block 7, Profile 5 in the May-June 1974 storms
- Peak storm erosion of 190 m<sup>3</sup>/m above AHD was measured at Block 5, Profile 2 in the June 1978 storm
- Storm erosion of 100 m<sup>3</sup>/m above AHD was measured along much of Wamberal in the August 1986 storm
- The 2006 profile was selected as the “average beach full” (accreted profile) for determining coastal hazard lines
- No evidence of beach rotation was observed, so no allowance was made for this

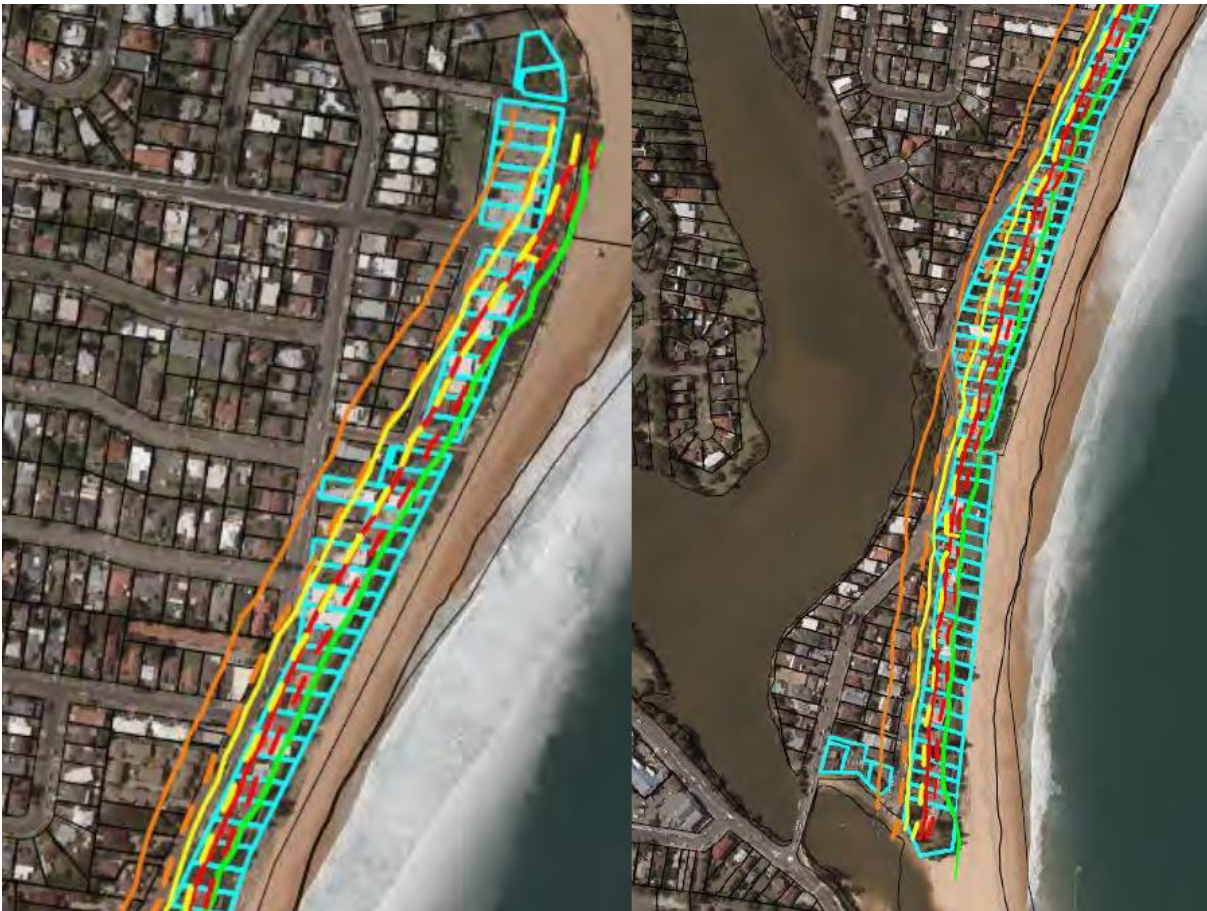
Notes: Orange solid line is 2100 Stable Foundation Zone

**Figure 9.1 2050 and 2100 coastal hazard lines (WP, 2017, page 431)**

The study also published hazard lines for 2100 (Figure 9.1), and included GIS plots of the stormwater (Figure 9.2), and water and sewerage system (Figure 9.3), which showed that (unlike some areas) most of the system was landward of beachfront buildings.

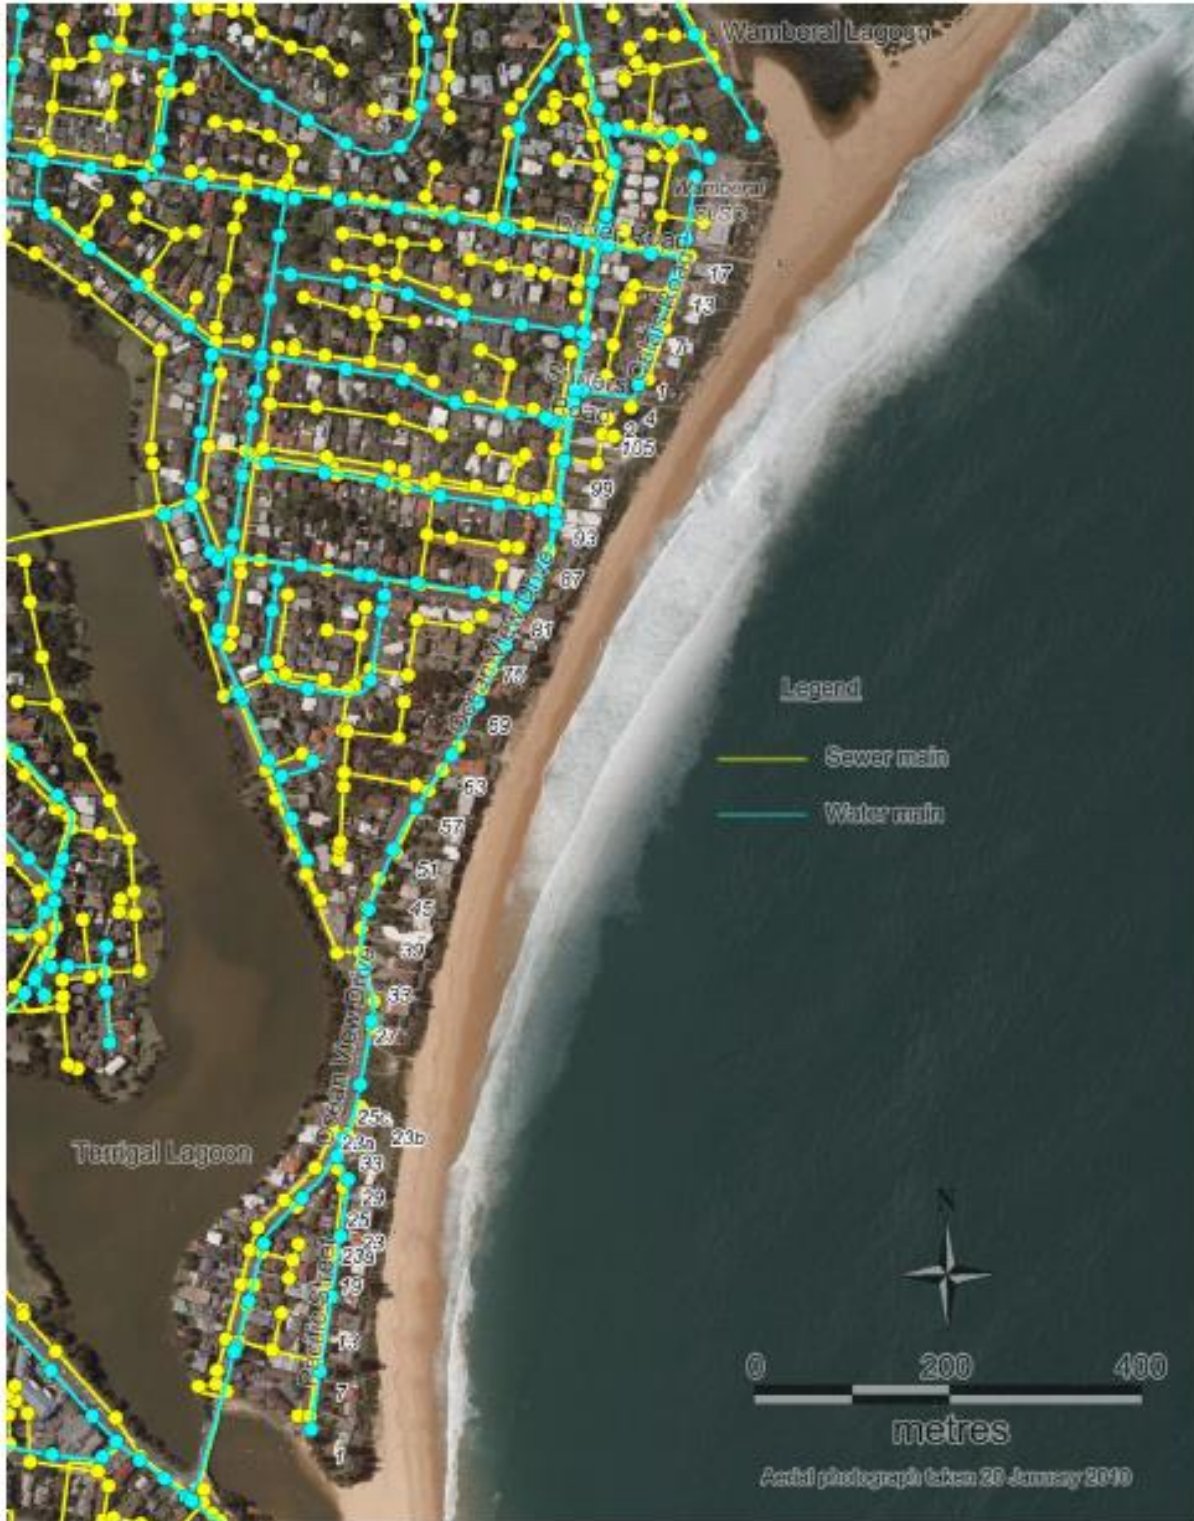
Figure 9.3 Sewer and water infrastructure (WP, 2017, Figure 9)
